**CITY OF BLUE RIDGE, TEXAS
PROFESSIONAL ENGINEERING SERVICES
For
2019 Texas Community Development Block Grant Program
Sanitary Sewer Rehabilitation Project**

This report presents the results of a limited subsurface investigation for a relatively newly paved stretch of asphalt roadway along Ridgeway Drive in Blue Ridge, Texas. It is understood that the roadway surface has shown signs of distress and cracking along the southern edge of the roadway in the eastbound lane that have developed shortly after completion of construction. The distress is generally characterized by longitudinal and edge cracking in the eastbound lane of asphalt pavement. At the time of this investigation, the distressed pavement appeared to be primarily within the eastbound lane between Station 6+00 and Station 17+50, with the most severe distress noted between Station 8+00 and Station 16+00.

The purpose of this investigation was to evaluate surface and subsurface conditions, analyze the potential cause(s) of the distress, and provide general recommendations for remediation of the distress.

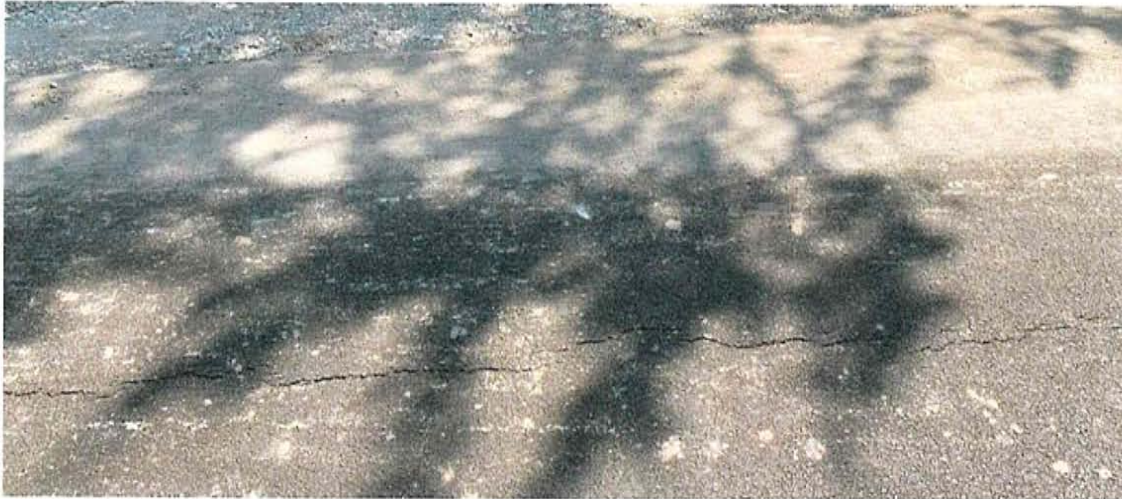
Shortly following completion of construction, a representative of HJA visited the site per client request on July 30, 2019. The purpose of this first site visit was to observe the distress that had begun to develop in the eastbound lane near the southern edge of the roadway. During this site visit, several small longitudinal and/or edge cracks were observed in the pavement surface in the eastbound lane. An example of the cracking present at the time of this first site visit is presented in the following Image No. 1. Representatives of both the contractor and project civil engineer were on-site at the time of this site visit. While on-site, the contractor was able to penetrate one of the more developed cracks with the metal wire stem from a survey flag to a depth greater than

12 inches below the existing asphalt surface. The ease with which the metal wire stem penetrated the cracked pavement structure indicates that the cracks developing in the asphalt pavement are most likely a result of reflective cracking due to issues in the underlying base and subgrade rather than fatigue cracking of the asphalt pavement due to loading only.

Image No. 1: Longitudinal cracking near southern edge of Ridgeway Drive, Blue Ridge, Texas, July 30, 2019.

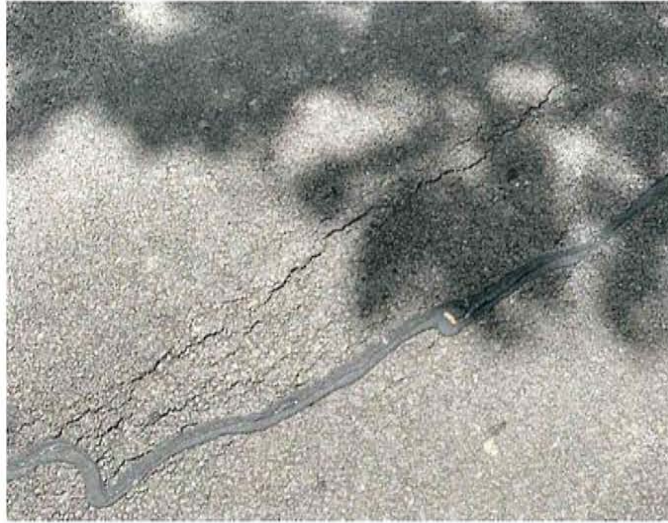
A second site visit was conducted August 23, 2019, at the request of the project civil engineer. The purpose of this site visit was to make additional visual observations concerning the distress developing at the roadway surface. Between the first and second site visit, the initial cracks had been sealed at the surface with a crack sealant material. Although the original cracks had been sealed, the second visit revealed what appeared to be the development of additional distress adjacent to the original cracks. The sealed cracks also appeared to be growing larger in length and width in some areas, resulting in a visible elongation or stretching of the overlying crack sealant. The pavement surface between the cracks and the southern edge of pavement appeared to have dropped or fallen slightly in elevation relative to the majority of the pavement surface. An example of a sealed crack and additional developing cracks noted at the time of the second site visit are presented in the following Image No. 2. Based on the observations collected during the first and second visits, it appeared that cracks were developing in the eastbound lane of pavement due to potential issues in the underlying base and subgrade and adjacent shoulder, and that the distress was worsening over time.

During both the first and second site visit, it was noted that the roadway shoulder along the southern edge of the pavement was at a relatively steep incline. Additionally, the surface of the southern roadway shoulder appeared to primarily consist of loosely placed or dumped soils.

Image No. 2: Sealed crack and new developing cracks near southern edge of Ridgeway Drive, Blue Ridge, Texas, August 23, 2019.

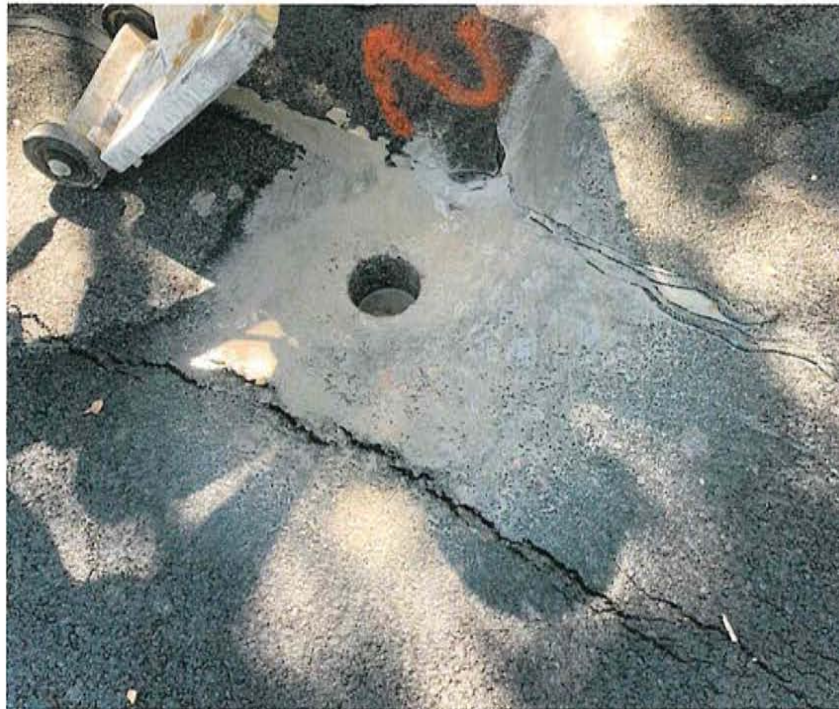
Following the second site visit, the City of Blue Ridge requested that the limited geotechnical investigation presented herein be conducted to determine the potential causes of the developing cracks and distress and provide recommendations for remediation of the distressed pavement. The field investigation was conducted on September 17, 2019 and consisted of gathering further site observations and drilling the four soil borings described in the preceding section. At the time of the field investigation, the cracking in the pavement visually appeared to have worsened since the second site visit conducted by HJA. An example of the extent of pavement cracking at the time of the field investigation adjacent to Boring No. 2 is presented in Image No. 3. In this image, a previously sealed crack can be seen south of the boring location, while a newer large developing crack can be seen just north of the boring location.

Based on the consistency of the materials encountered in the borings conducted for this investigation, the conditions visually observed onsite, review of publicly available aerial imagery, and a review of construction plans, documents, and reports, there appear to be a number of probable causes of distress. These likely causes include potential consolidation and settlement of underlying clay soils due to the presence of heavy vegetation and tree cover directly south of the roadway, possible settlement due to improperly placed fill, and lack of pavement edge support due to poorly placed fill and steep side slopes on the southern shoulder.

Image No. 3: Sealed crack and new developing cracks near southern edge of Ridgeway Drive, adjacent to Boring No. 2, Blue Ridge, Texas, September 17, 2019.

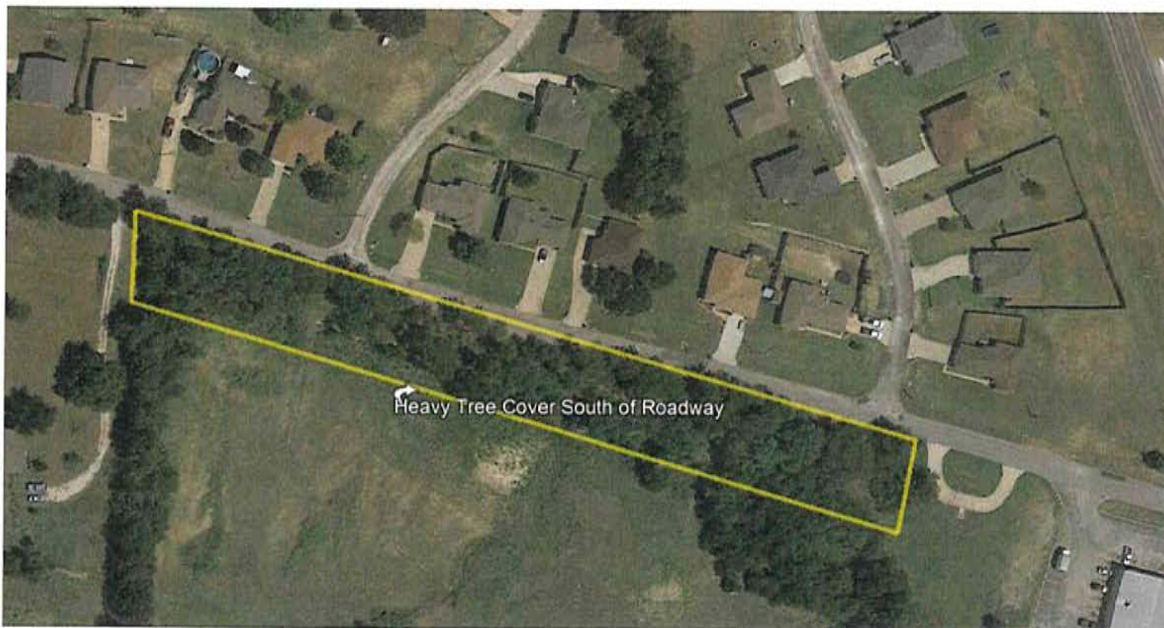
Land south of the pavement edge is occupied by heavy vegetation and tree cover which are adjacent to the pavement edge as presented in Image No. 4. A number of large trees are near the roadway edge, with canopies spanning over the eastbound lane. Over time, trees and other vegetation will desiccate clay soils, resulting in shrinkage of the subgrade. This shrinkage will typically manifest as settlement of ground supported features, including pavement. This is supported by the soils encountered below the paving being in a dry condition, evidenced by the Liquidity Index results of less than zero extending to depths of 4 to 9 feet below existing grades as well as the low moisture contents and high free-swell potential of the clay subgrade soils. Based on the depths the dry materials extend to, and the degree to which the soils had dried out, these conditions can be attributed in part to desiccation of the clays by the adjacent trees.

Image No. 4: Heavy tree cover near presence southern edge of Ridgeway Drive, Blue Ridge, Texas
Google Earth V 7.3.2.5776. (September 6, 2017). Blue Ridge, Texas, United States of America
33° 17' 55.83" N, 96° 23' 49.28" W, Eye alt 1964 feet.
Google Earth. <http://www.earth.google.com> [October 10, 2019].

If possible, trees should not be allowed to grow next to the paving and/or shoulder. Over time, vegetation will desiccate the clays, resulting in shrinkage of the subgrade. This shrinkage will be manifested as settlement of ground supported foundations. All trees should be planted a minimum of 1-1/2 times the mature height of the tree from the edge of the roadway. If trees will be planted next to the paving, future distress in the form of cracking, separation and settlement should be anticipated. To limit the impact heavy vegetation would have on pavement performance, consideration should be given to installing a vertical root barrier between the tree and the foundation. As a minimum the barrier should consist of a four-inch wide lean concrete wall extending to a depth of 6 feet from finished grades. An alternative is to use a minimum 6-mil thick plastic sheet draped within the excavation and backfilled using sand or gravel. Alternatively, a "root-barrier" system similar to that produced by DeepRoot® may be installed along the edge of the shoulder. Vegetation must not be allowed to grow between the pavement edge and root barrier.

Any trees to be cleared from or within ten feet of the roadway should have the root systems removed and the excavations filled with on-site soils placed under controlled conditions. Soils should be placed as presented in the **Earthwork Recommendations** section.
